**BRITISH COLUMBIA
 ARCHAEOLOGICAL IMPACT ASSESSMENT
 INTERIM REPORT FORM**

HCA HIP 2021-0151	Archaeological Impact Assessment of 800 University Drive Phase 1
-------------------	--

4.1	<i>Description:</i>	Commercial and residential development
4.2	<i>Location:</i>	800 University Drive, Kamloops, BC
4.3	<i>NTS Mapsheet</i>	92I.069

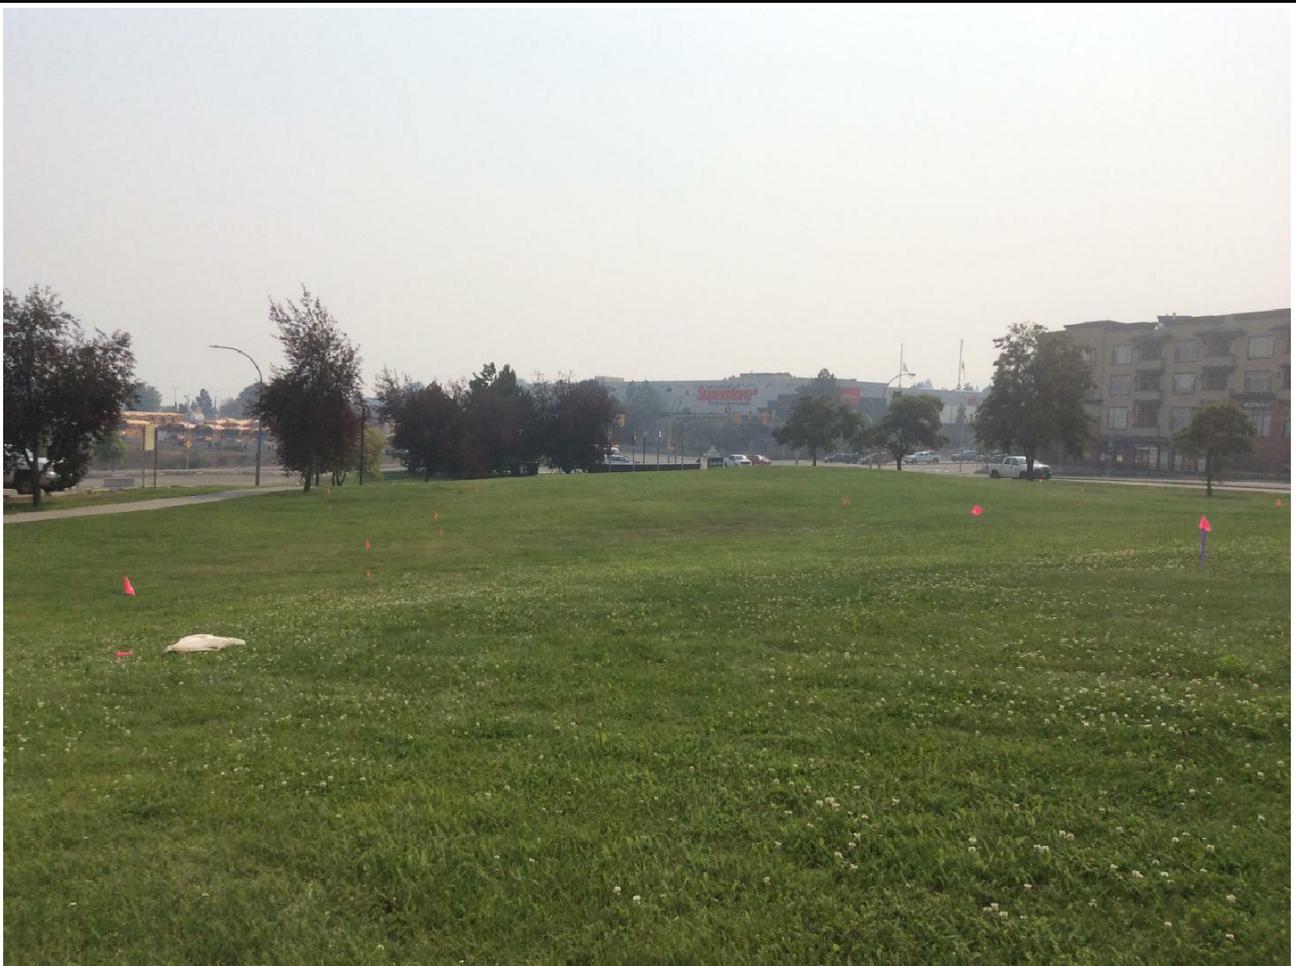
Photo 1. View east of project area before commencement of auger testing.

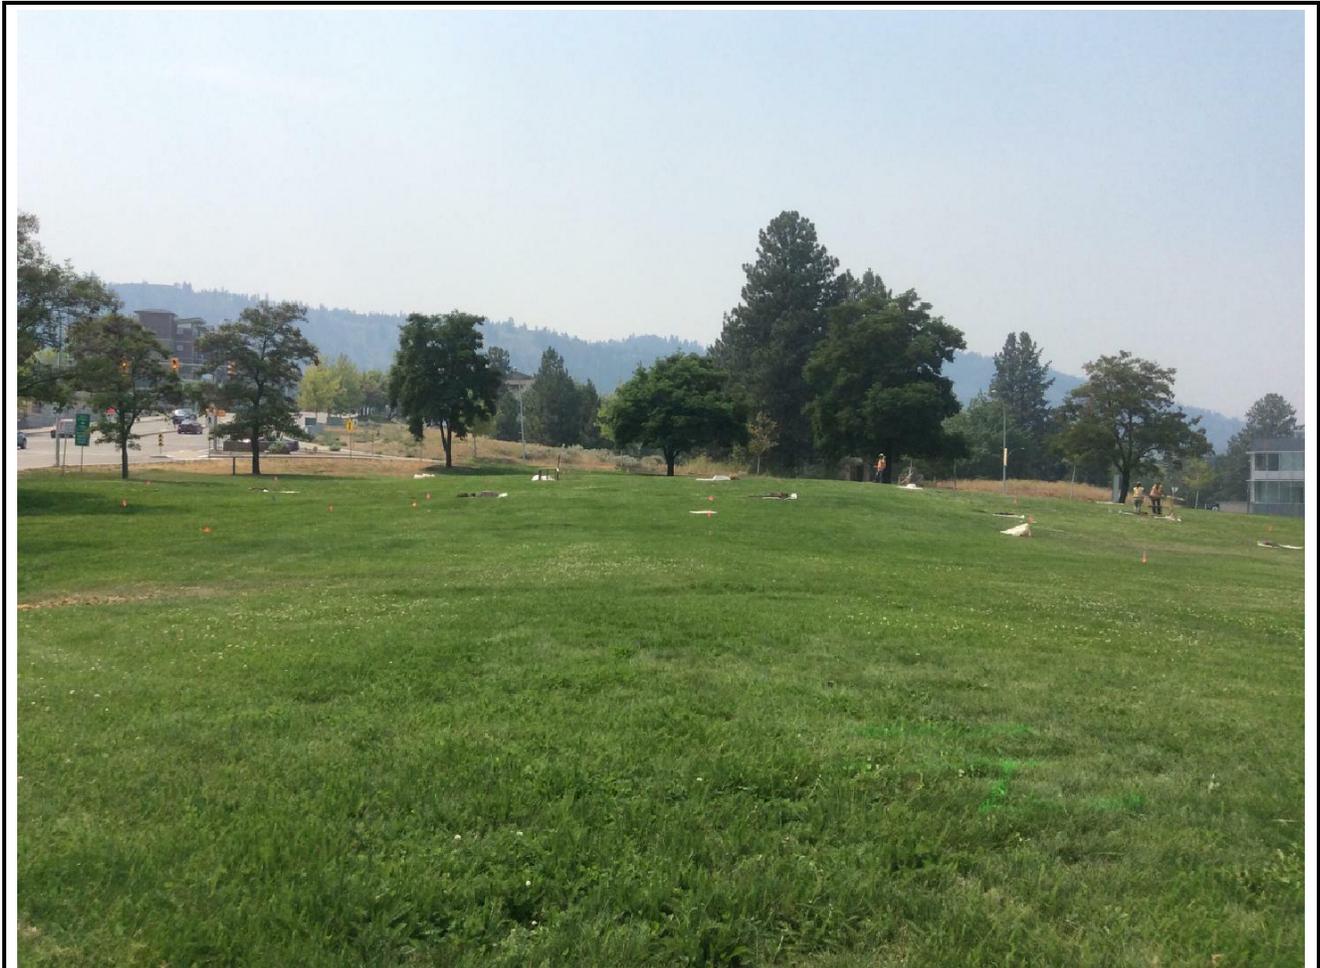
Photo 2. View west during auger testing.

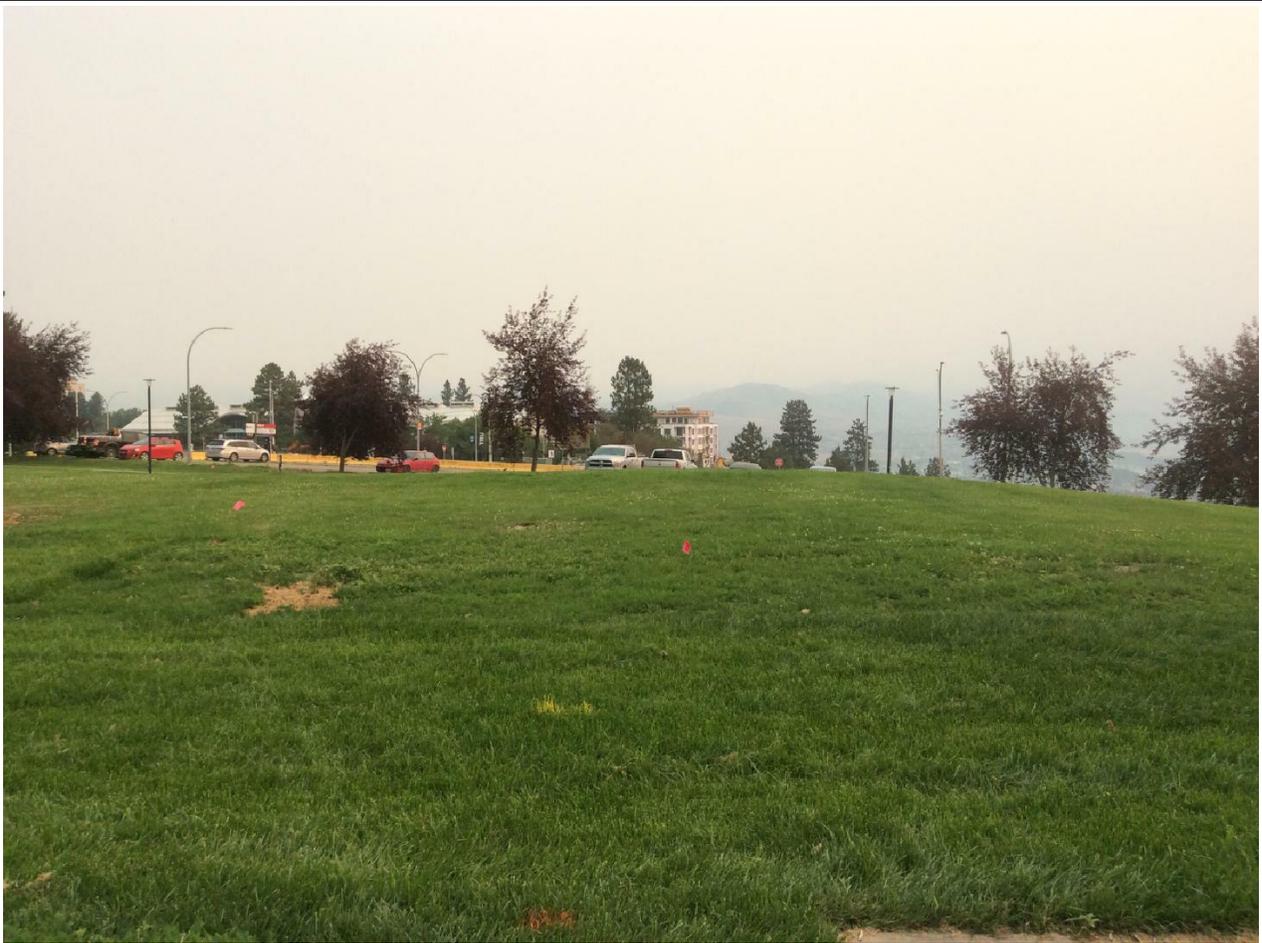
Photo 3. View north of project area after completion of auger testing. Note: this area represents the historic landfill.

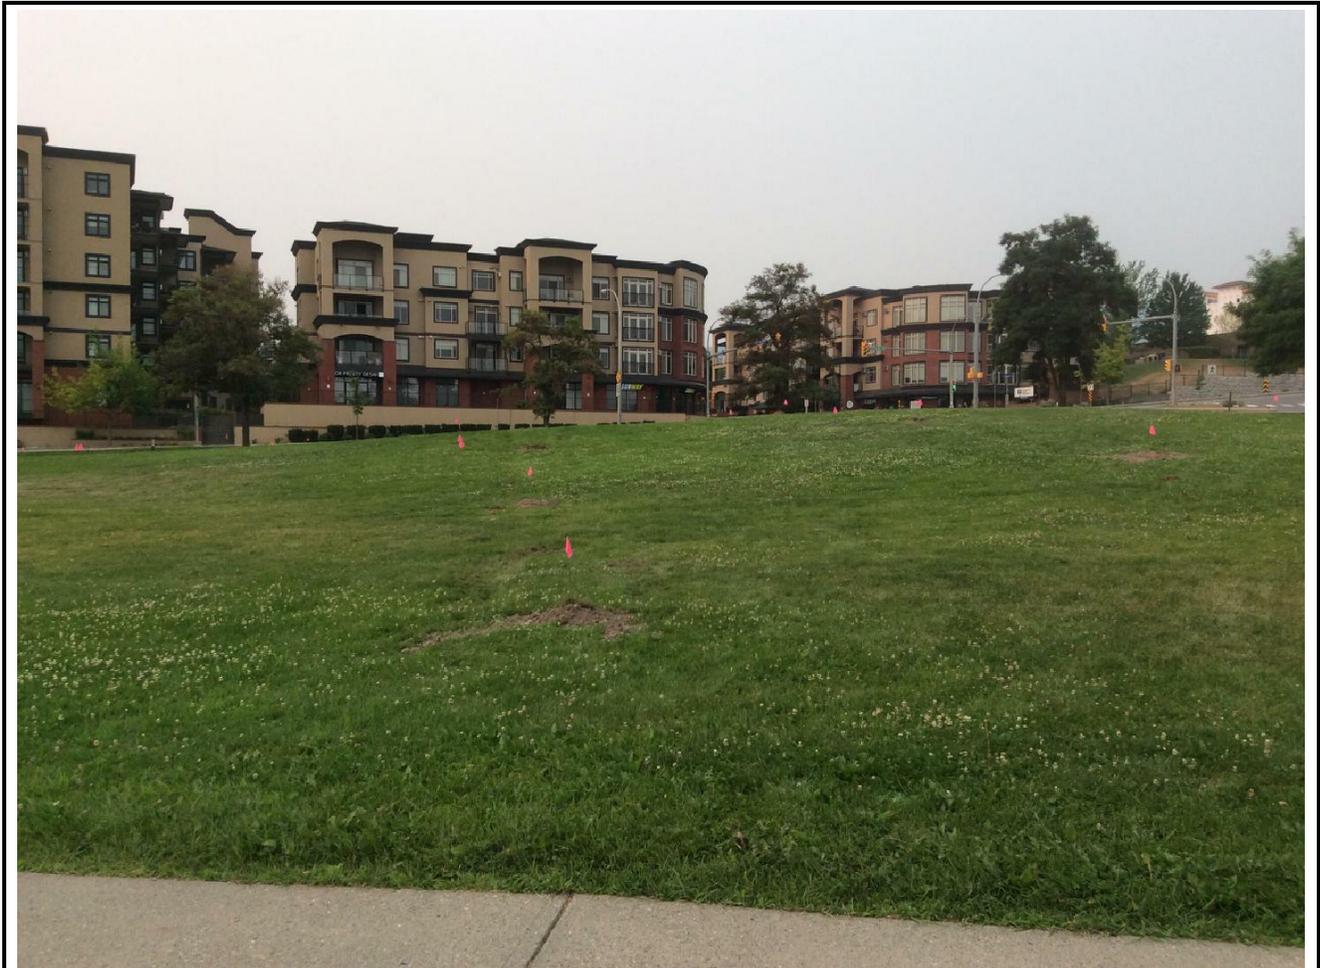
Photo 4. View south of project area after completion of auger testing. Note McGill Road running east-west.

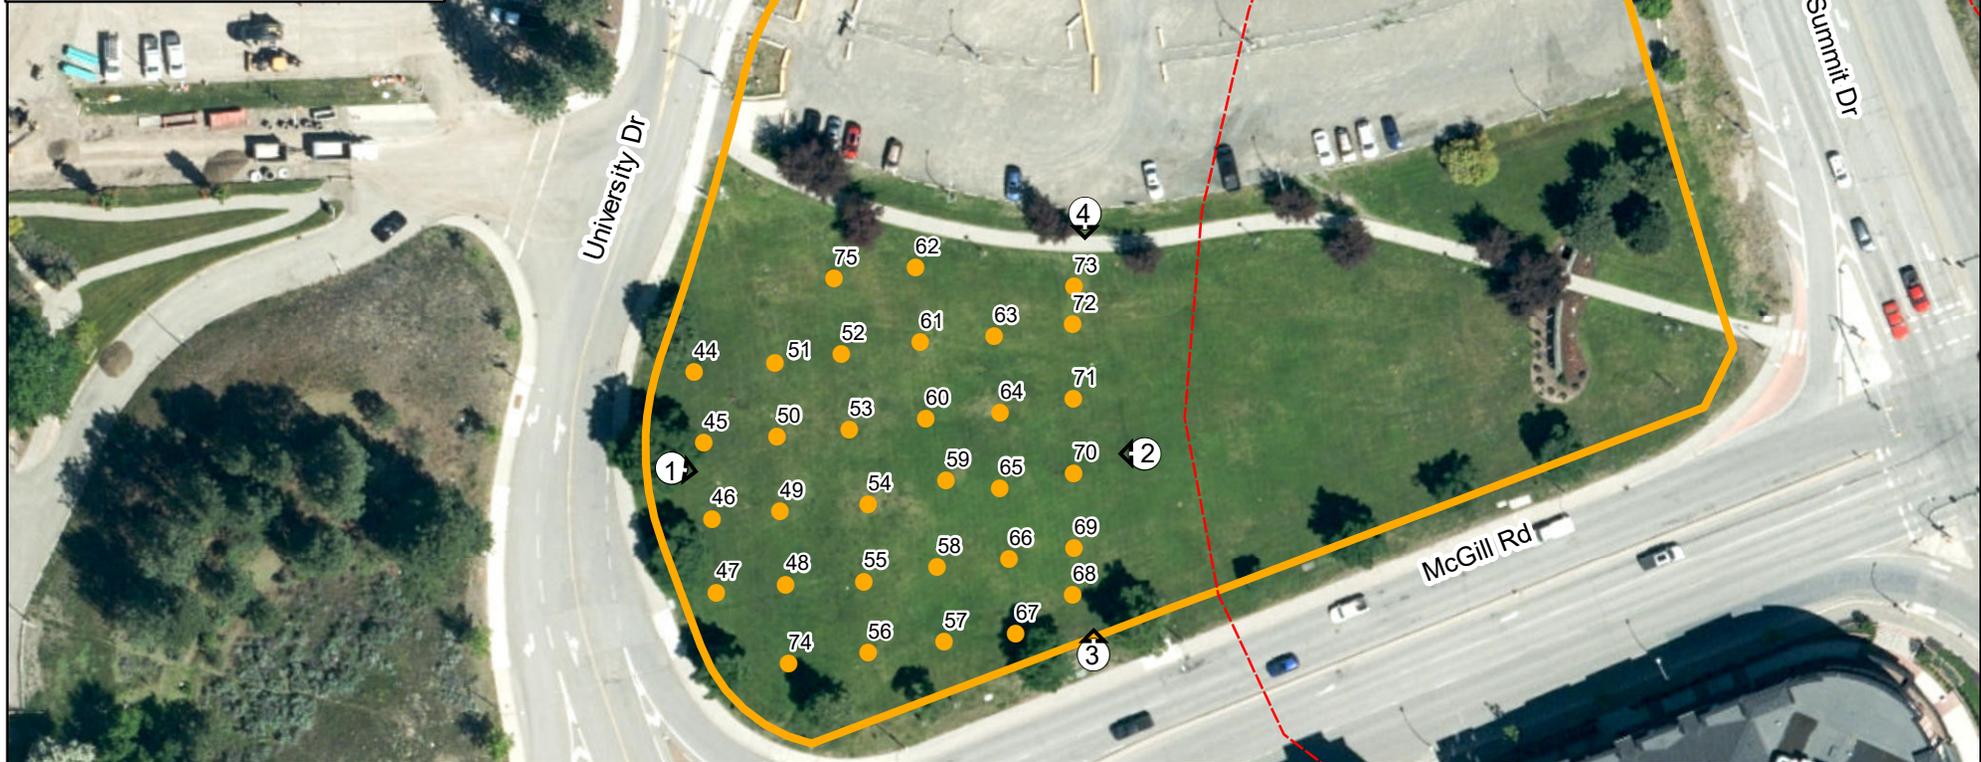
Figure 2. Auger Test Area
Project: Archaeological Impact Assessment
of 800 University Drive Phase 1

2.3	<i>Results:</i>	
	<p>A total of 31 tests were laid in 10 m grid spacing within areas containing high archaeological potential, with 20 of the 31 tests excavated by auger. The remaining 11 tests were not excavated due to concerns of contamination from the historic Guerin Creek landfill. These tests yielded negative results for archaeological materials.</p>

2.4	<i>Management Recommendations:</i>	
	<p>No further work is recommended for the assessed auger test area, as well as the northern parking lot area; should excavation in the western half of the project area exceed the depth of landfill materials, archaeological monitoring is recommended pending safe access for TteS field staff.</p>
